City of Piedmont
CITY COUNCIL AGENDA REPORT

SUBJECT: Receipt of a Presentation from Richard Young of Aquatic Commercial Consulting Regarding a Current Condition Assessment of the Piedmont Community Pool

City of Piedmont Community Swimming Pool Facility Pool Evaluation

September 2018

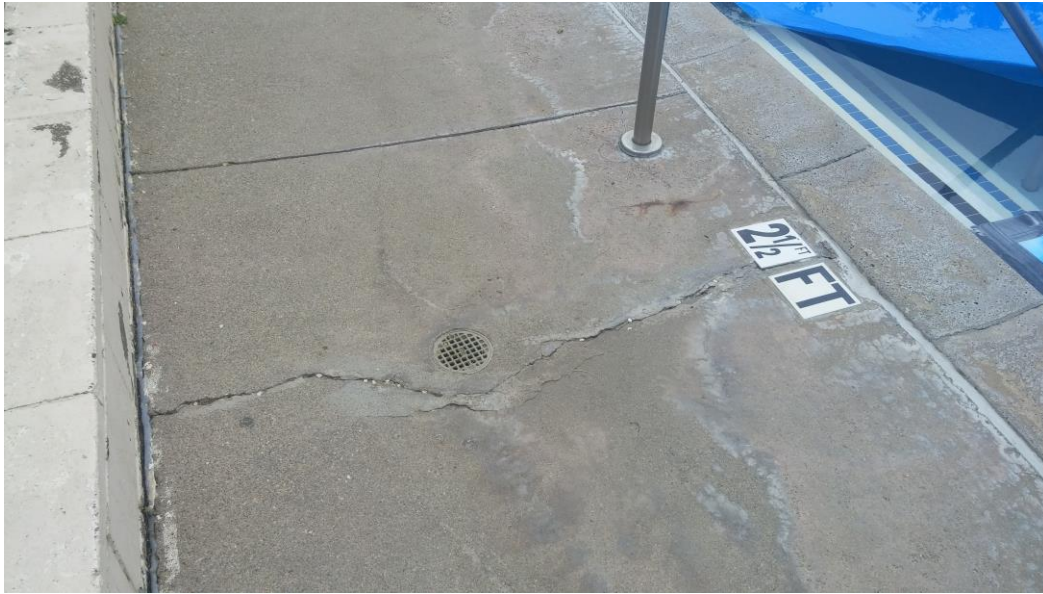
- A. There are number of deck areas with unsightly stains or failed concrete surfaces, cracks and uneven sections. These are especially evident around the Medium Pool deck area (see Medium Pool vessel section). These present a trip hazard and are lacking compliance with CHSC, MAHC and IS. PP-1, 2, 3, 4

PP-1 Deck cracks, staining

Address those items that may cause injury.

1. Grind down any areas that present a trip hazard. (2-3 day pool closure)
2. Fill any cracks that present a toe-stub hazard.

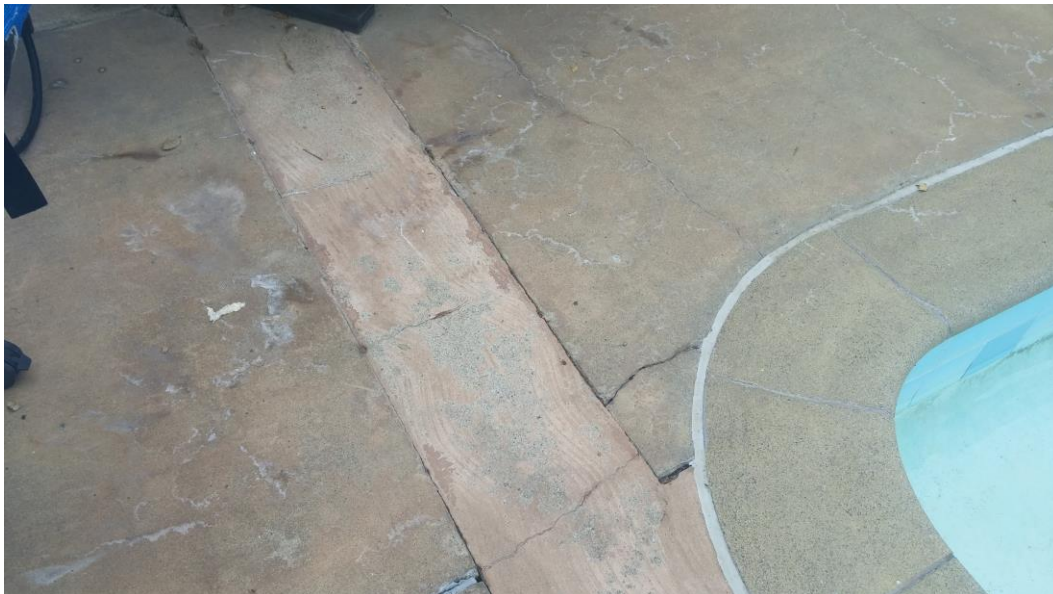
PP-2 Deck cracks, sections replaced

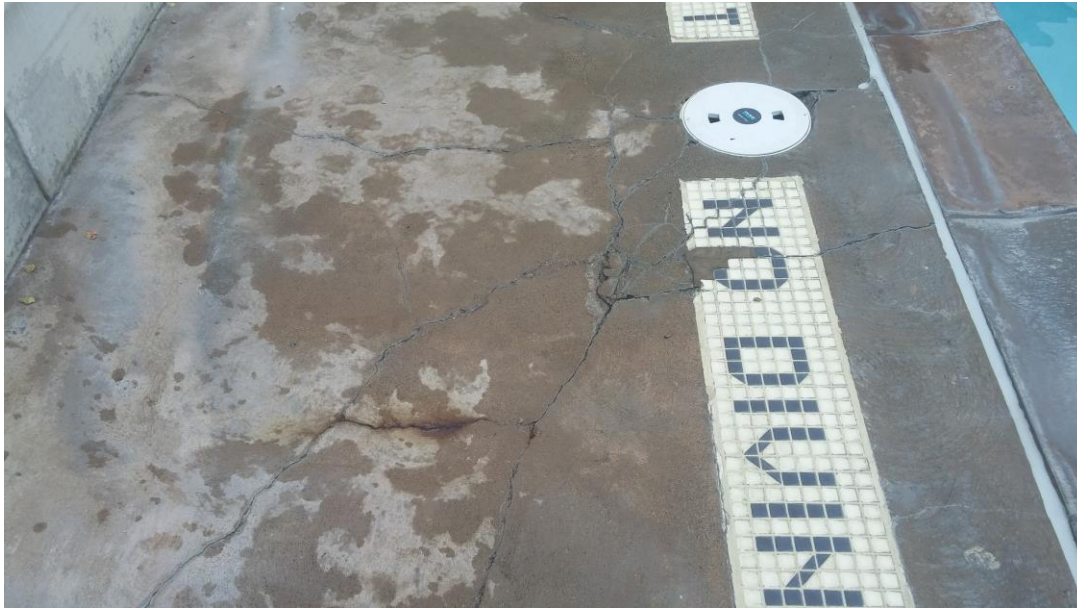
PP-3 Deck issues

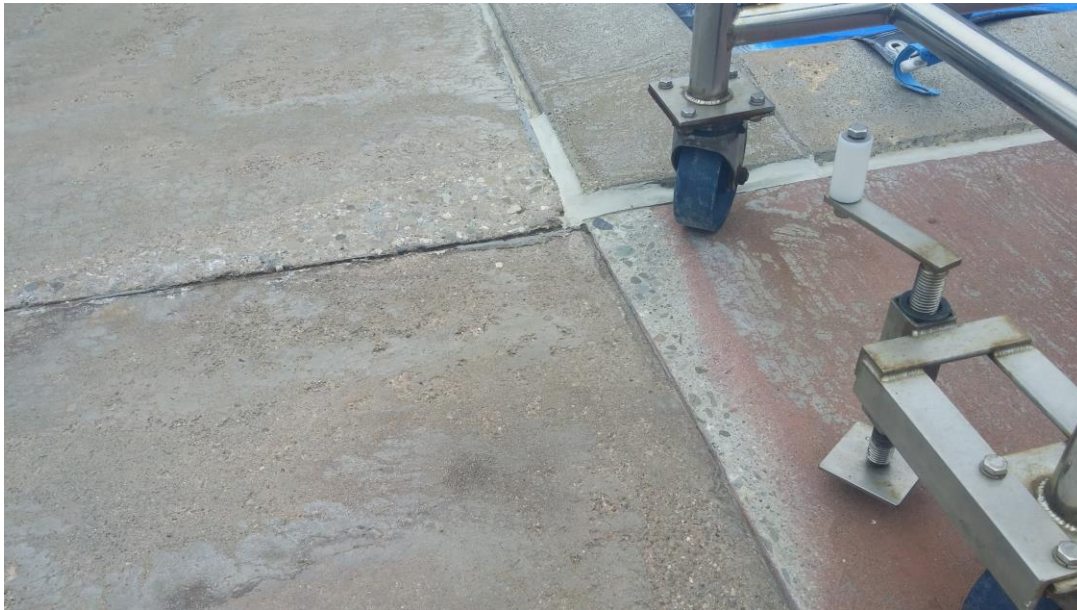
PP-4 Deck issues, edges ground down on displaced concrete sections

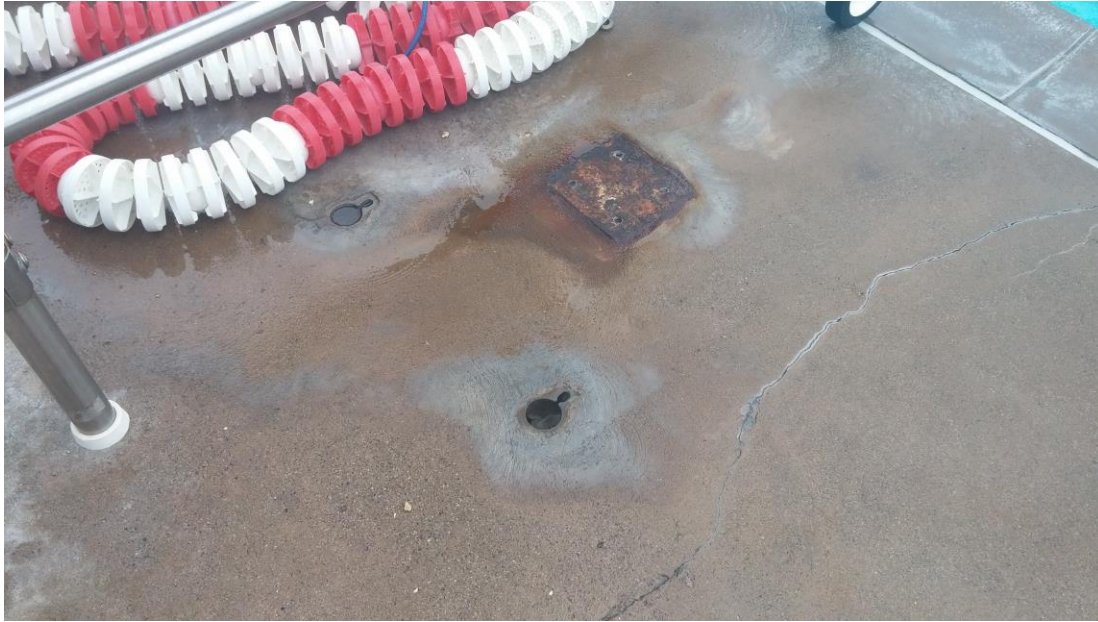
- B. There are abandoned in-deck anchors in several locations that present a toe-stub and trip hazard or are unsightly. PP-5

PP-5 Abandoned deck anchors

1. Fill all abandoned deck anchors with concrete.
2. Place appropriate covers on all deck anchors when not in use.

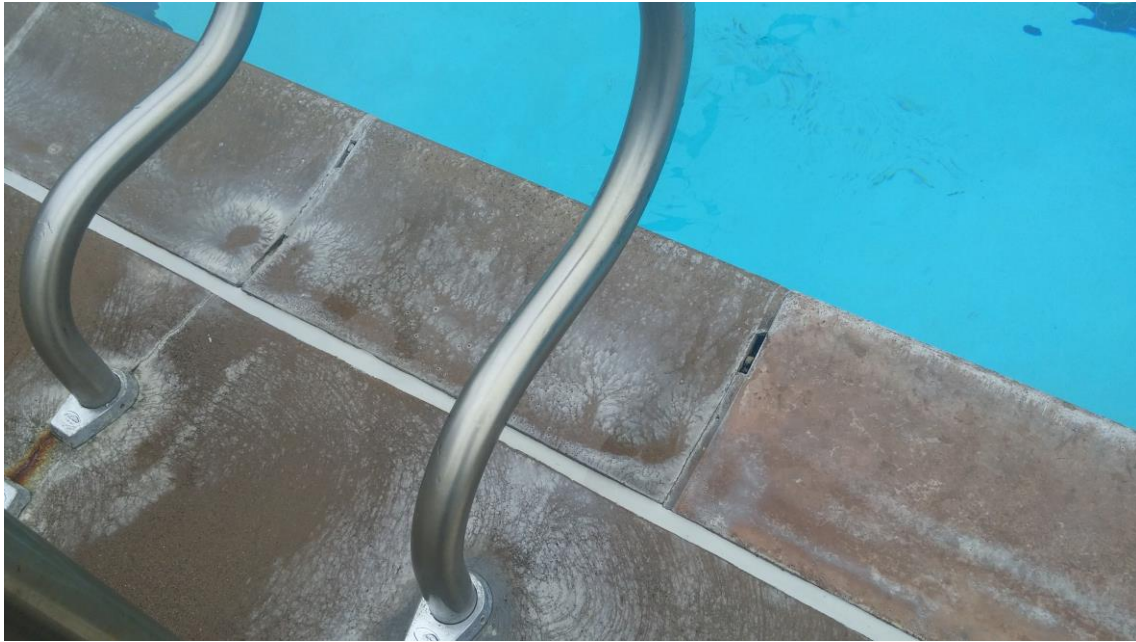
The staining and calcification cannot be significantly improved without full deck replacement.

PP-6 Calcium and salt scaling

Recommendation: None at this time.

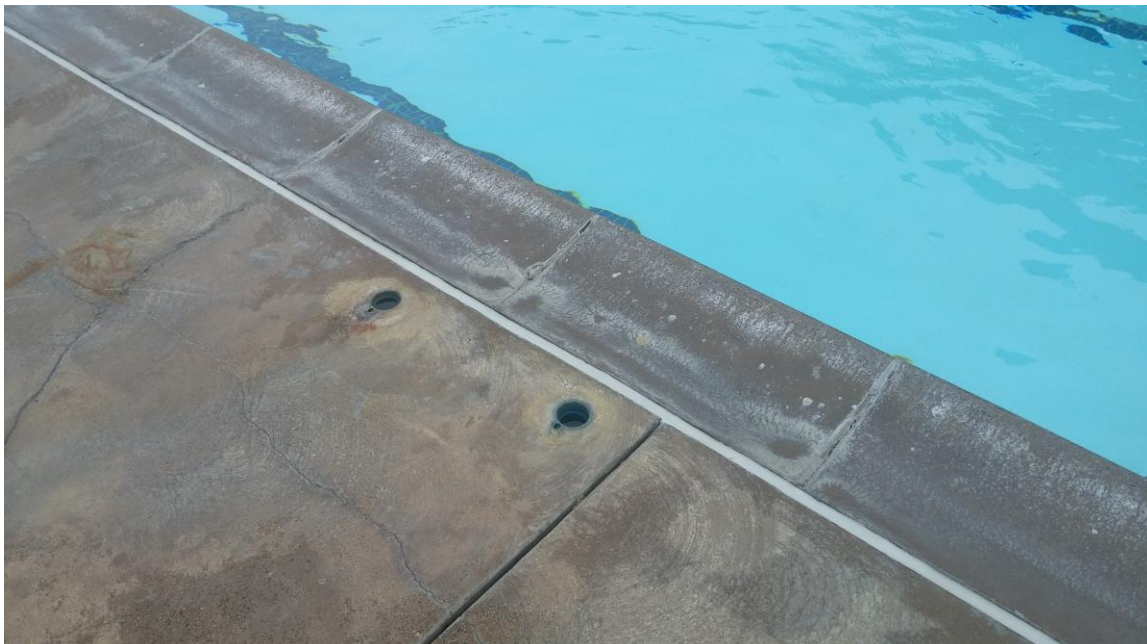
PP-7 Scaling deposits on deck

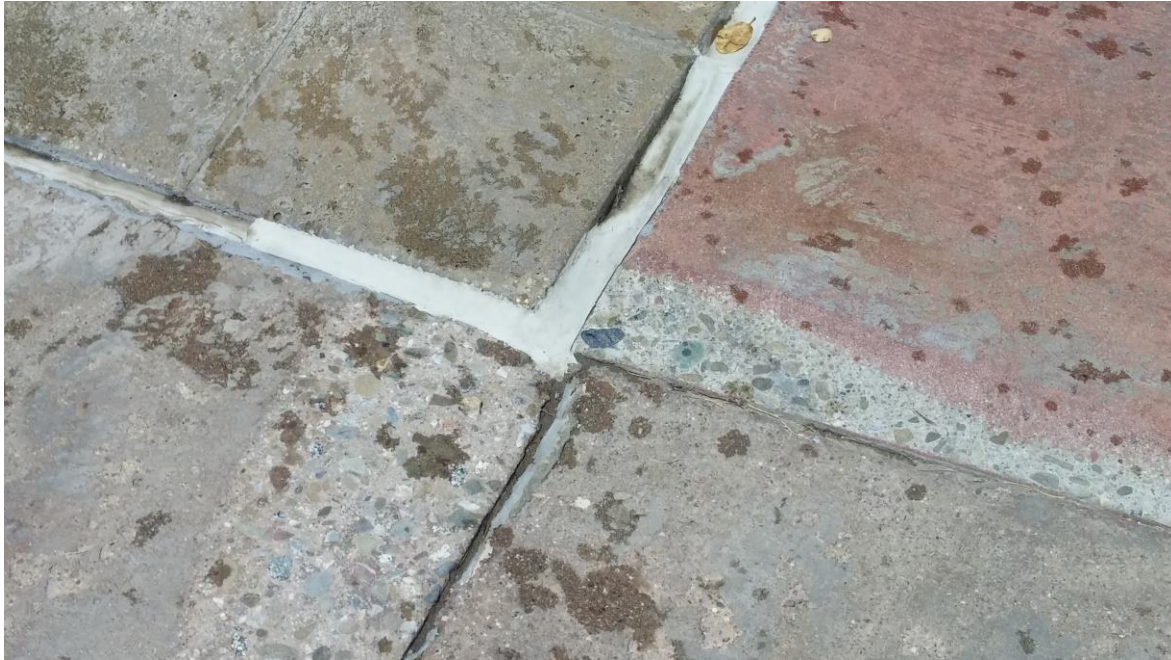
- D. The expansion joint caulking around the entire pool between the deck and the coping stones has failed allowing water to enter in behind the coping. This results in expansion and contraction and has resulted in displacement and loosening of many of the coping stones. In addition, the gaps present safety hazards. PP-8.

PP-8 Expansion joint/caulk failing

Remove and replace the failed mastic (caulking) on all expansion joints and deck/coping stone cracks.

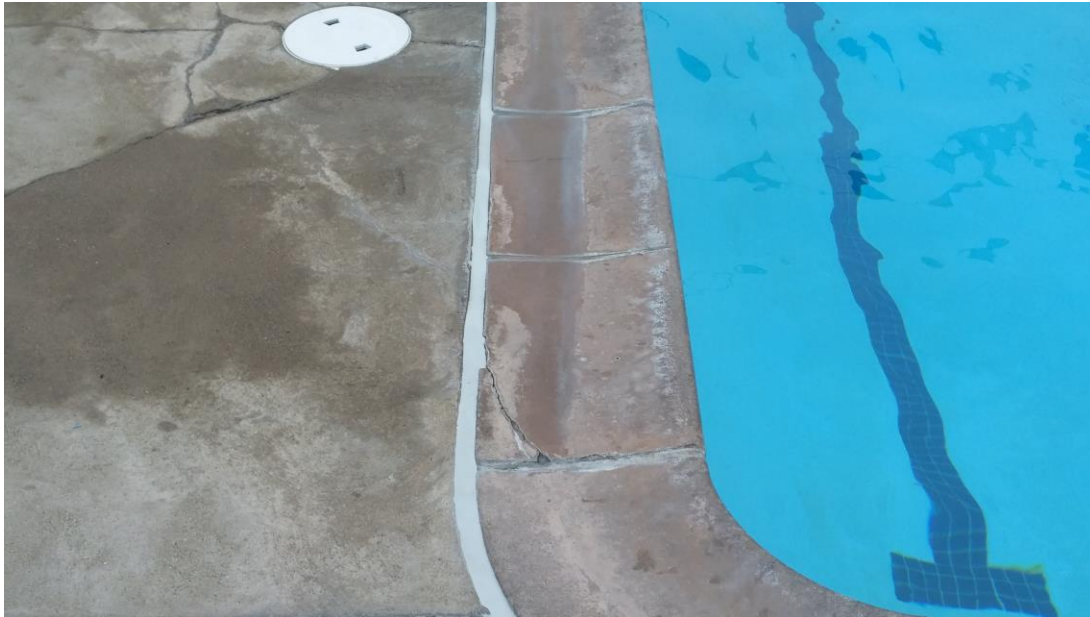
- E. Many of the coping stones are cracked and have been reset and/or replaced. Cracks appear under the stones in the grout and several stones can be moved by hand. These loose stones present a safety hazard and several have had to be removed over the past two years. Many have missing grout between the stones.
PP-9, 10

PP-9 Coping stone failure

Remove all of the coping stones and install new safety-grip stones securely with non-shrink, waterproof grout. Attempts to save the existing coping stones is not recommended as they often crack when removed and are labor intensive to clean up for re-installation.

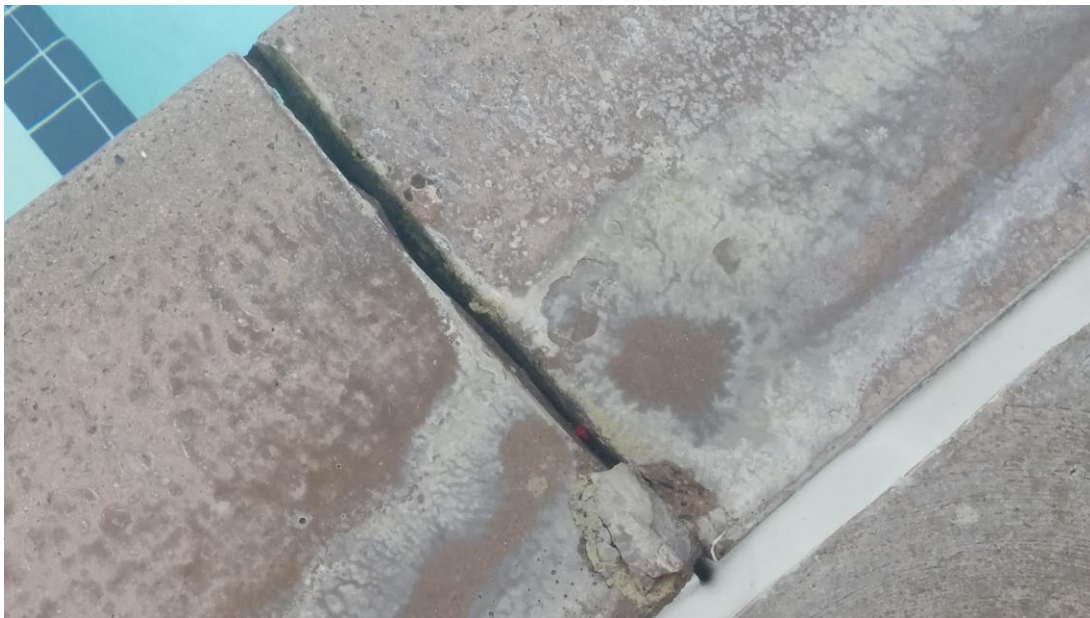
PP-10 Coping stone cracks, missing grout

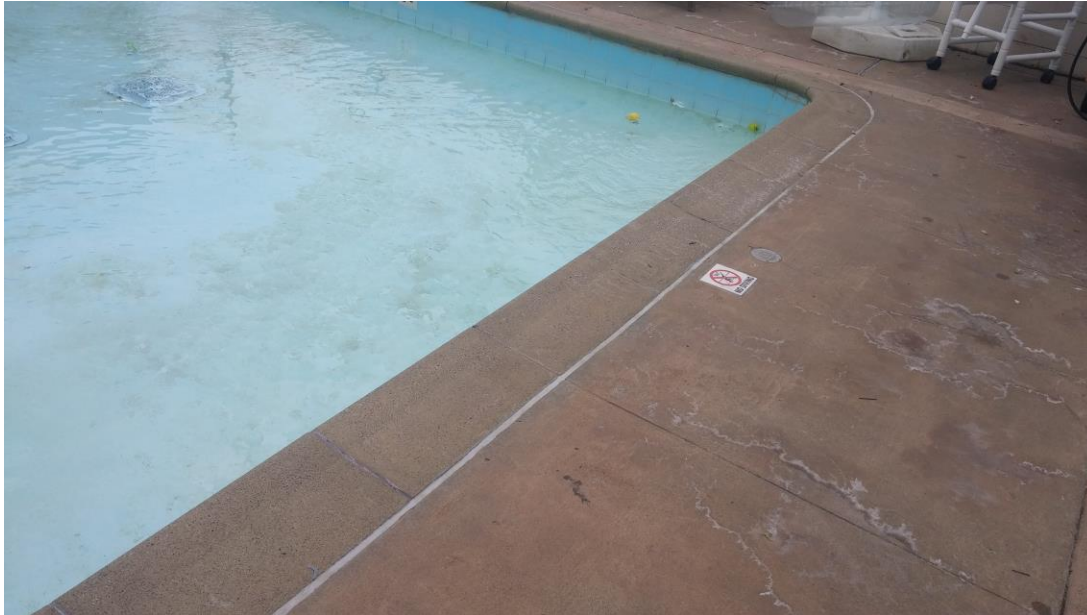
- F. There are no deck depth marker signs around the Wading Pool per CHSC which presents a risk hazard. PP-11 NOTE: See also Pool Vessel section.

PP-11 Missing deck depth markers on Wading Pool

Install new depth marker signage, two at each end and one on either side of the pool per CHSC. These may be “stick-on” signs.

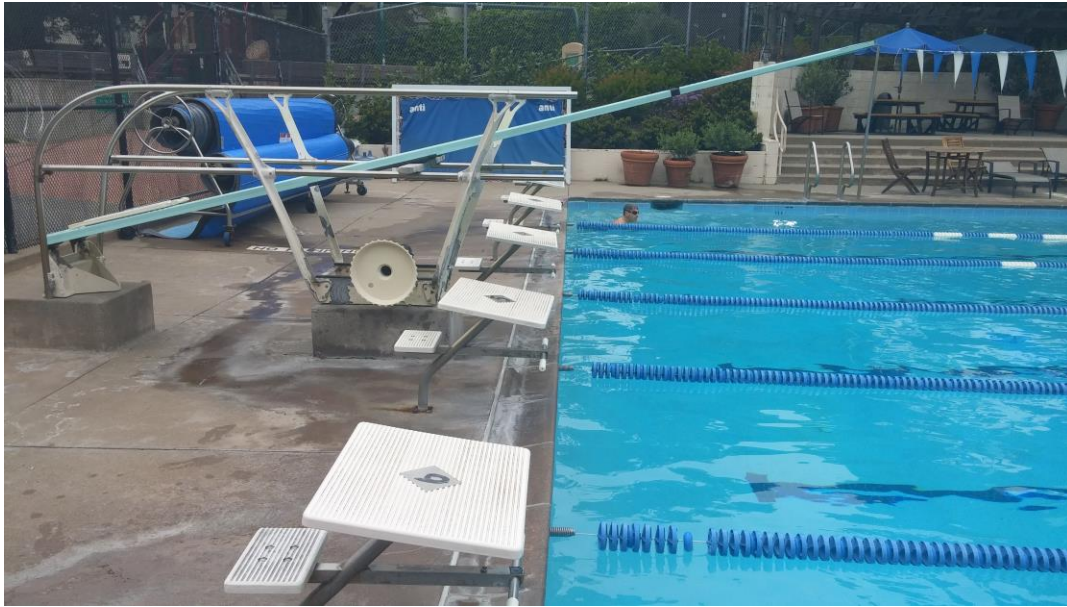
- A. The starting platforms are more than 15 years old and appear to have been installed poorly and are not in line (plumb) with the pool edge. Several of the anchors are corroding and staining the concrete around anchors. The steps and platforms are showing signs of deterioration.

It appears that the starting platform posts have been fastened to the deck anchors with something other than stainless steel hardware. In addition, CHSC and the MAHC call for the platforms to be covered or removed when not in use. PP-12, 13

PP-12 Starting platforms

1. Install proper starting platform safety covers or remove them after each swim team practice. Starting platforms may only be in place and used by swim team members when a coach is present. Covers are available through distribution. CHSC, MAHC

3. Remove the platform posts and reinstall them with stainless steel hardware.

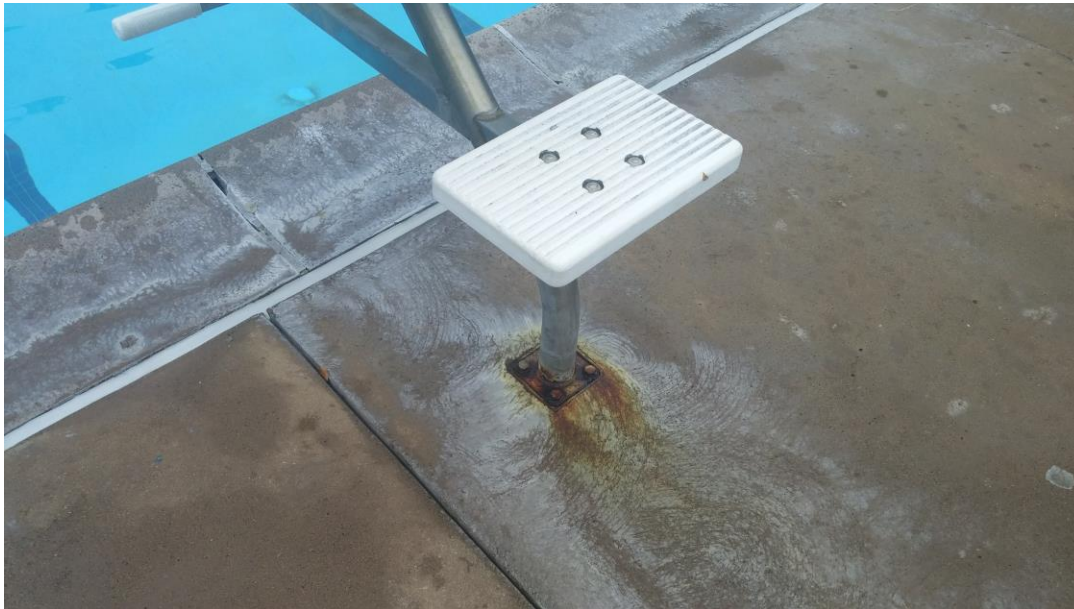
PP-13 Starting platform anchor corroding

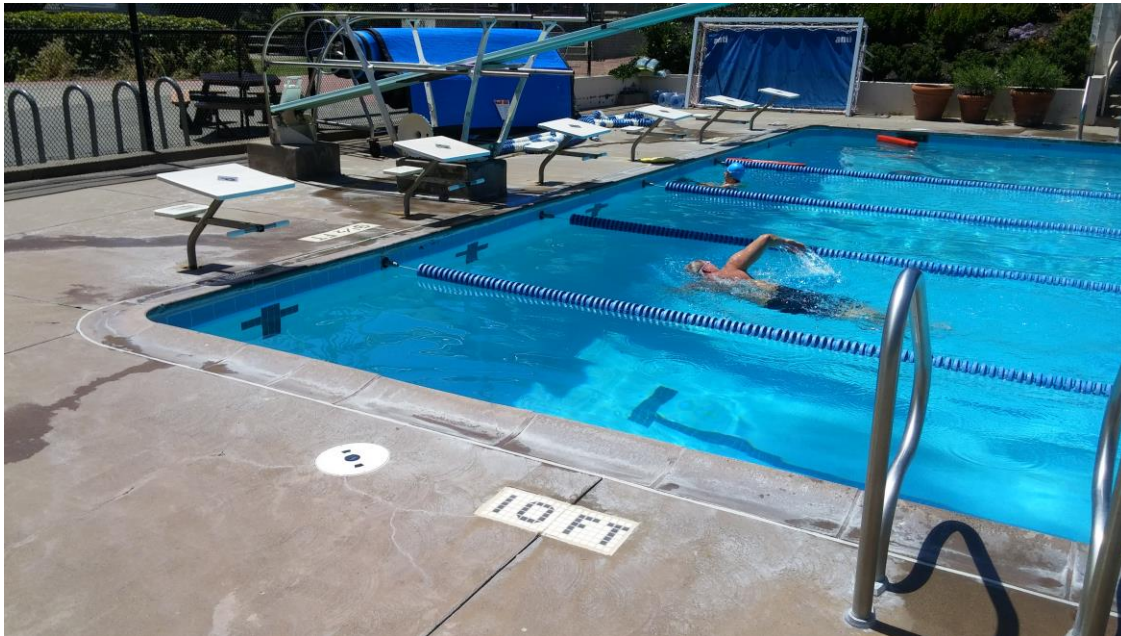
- B. The diving board does not comply with current CHSC or sanctioning diving agencies, as the depth of the pool is too shallow for a full 1-meter platform and board. A minimum of 11.5 feet of water depth is required. The diving board adjustable fulcrum should always be in the forward and locked position unless a diving coach or instructor is present. The diving stand coating has deteriorated considerably and the aluminum structure is exposed to the elements and is corroding. The diving board surface is worn and presents a slip hazard. PP-15, 16, 17

PP-14 Diving board is not compliant Requires 11.5 feet depth

1. Remove the 1-meter stand and install a $\frac{3}{4}$ meter stand with a recreational diving board. This will require County Health Department approval.

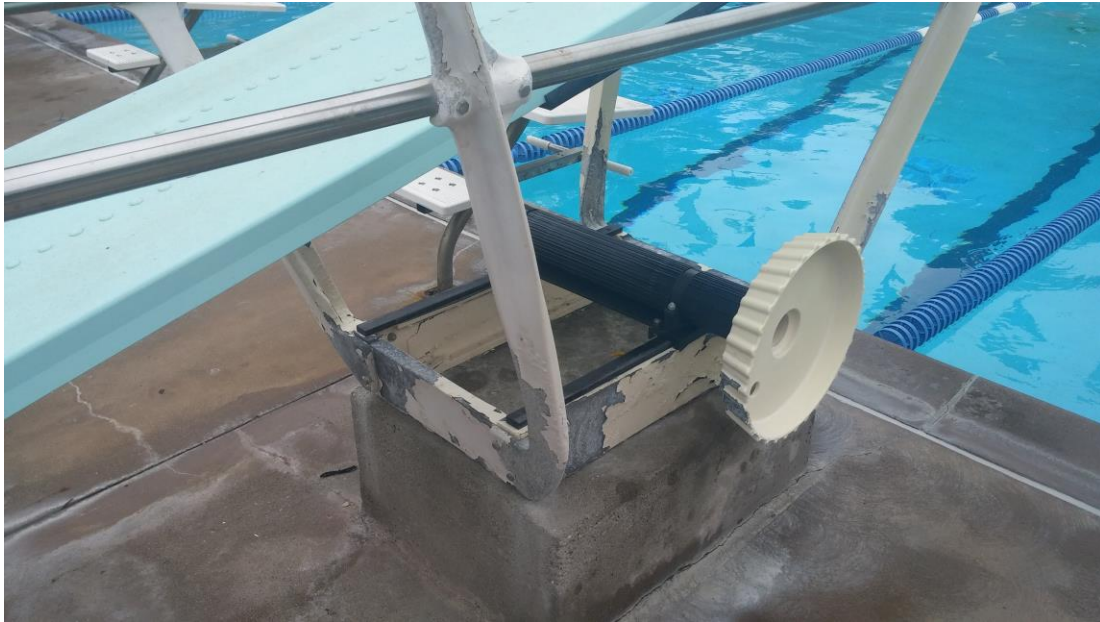
PP-15 Diving board standard coatings failing /corroding

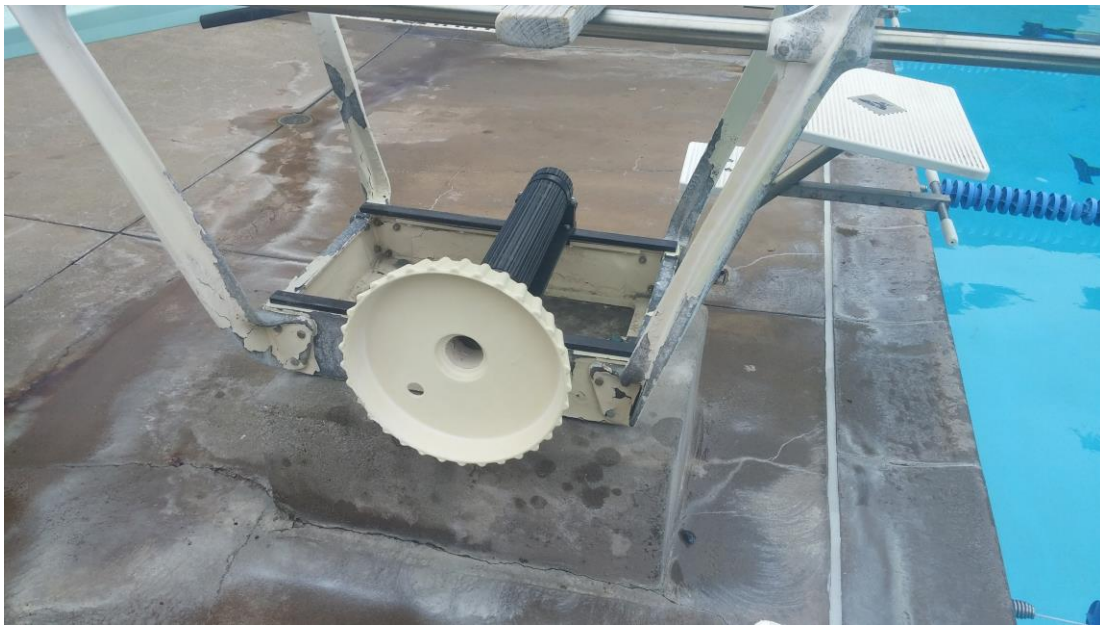
PP-16 Fulcrum not in the forward and locked position

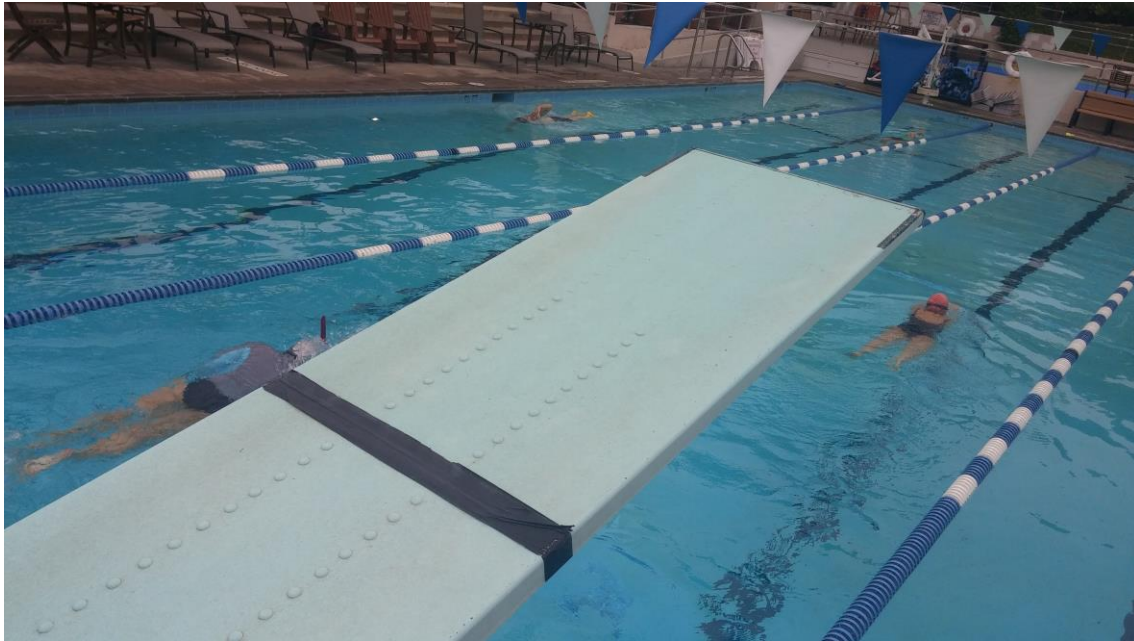
PP-17 Diving board slip resistant coating failing

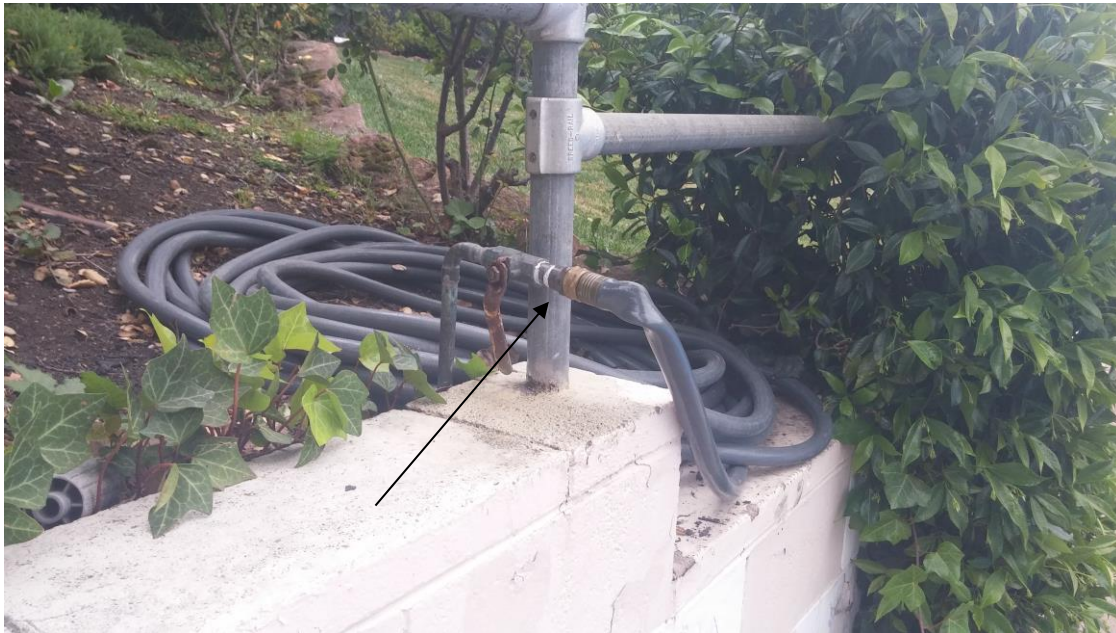
- C. There are several hose bibs that are not protected by anti-siphon devices as called for by the CHSC, NPC. PP-18

PP-18 Non-compliant hose bibs

Install anti-siphon devices on all hose bibs located on the pool deck.

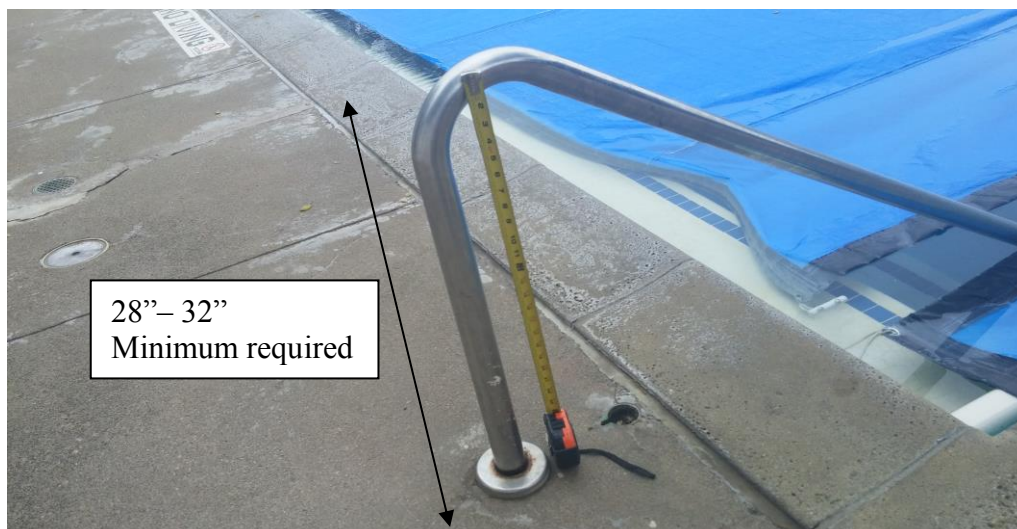
- D. One of the grab rails on the Medium Pool is not compliant with the Federal ADA and is mounted too low. 32" required minimum. PP-19

PP-19 Non-complaint step handrail on Medium Pool

Install a code compliant rail. The existing anchors may be used. The other rails use a 3-bend-type step rail.

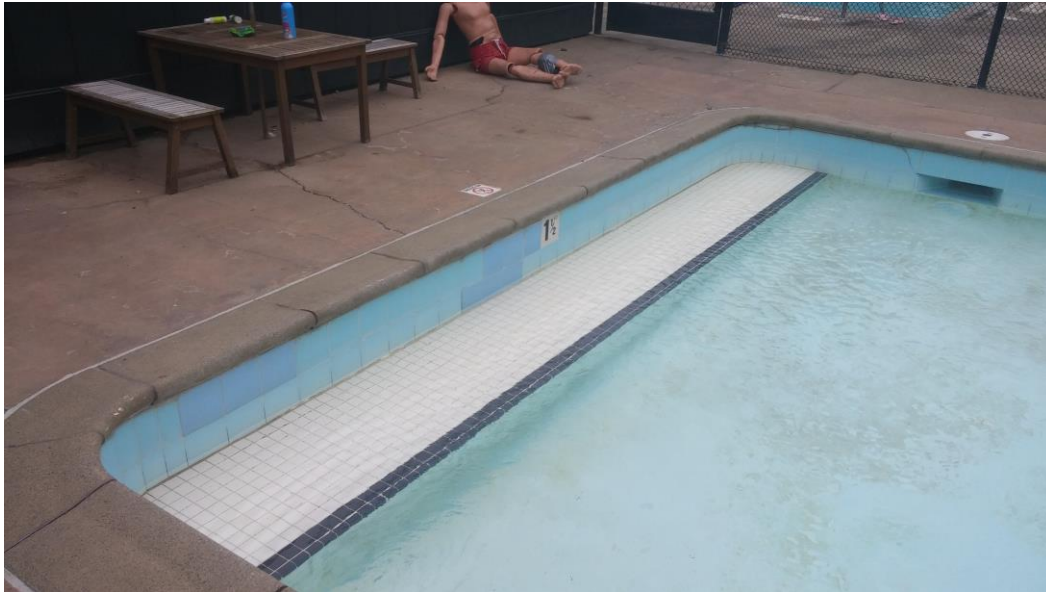
- E. The Wading Pool does not have any step handrails on the entry step for the pool and is not in compliance with the CHSC or MAHC. PP-20

PP-20 Handrails absent on Wading Pool steps

Install at least two handrails on the wading pool steps. Bond anchors per code.

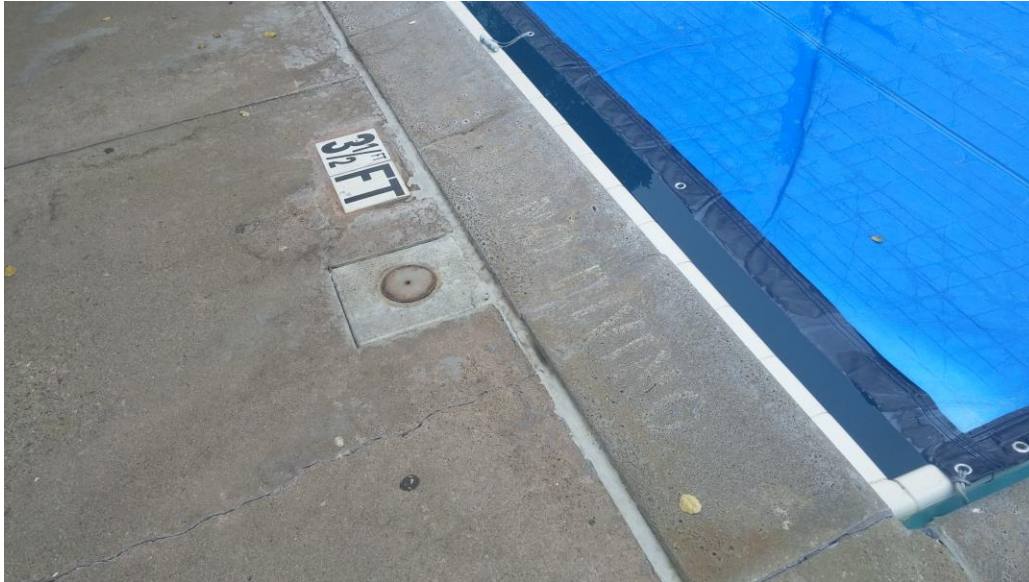
- F. There is no ADA compliant lift on the Medium Pool. The Wading Pool is too shallow for a lift; however, Federal ADA requires a ramp or zero depth entry. At the time of the inspection, the ADA pool lift for the pool was not in operating order. PP-21, 22

PP-21 Non-working and absent ADA approved pool lifts for Main and Medium Pools
Medium Pool lift anchor has been installed

1. Purchase and install a new ADA approved pool lift for the Medium Pool.

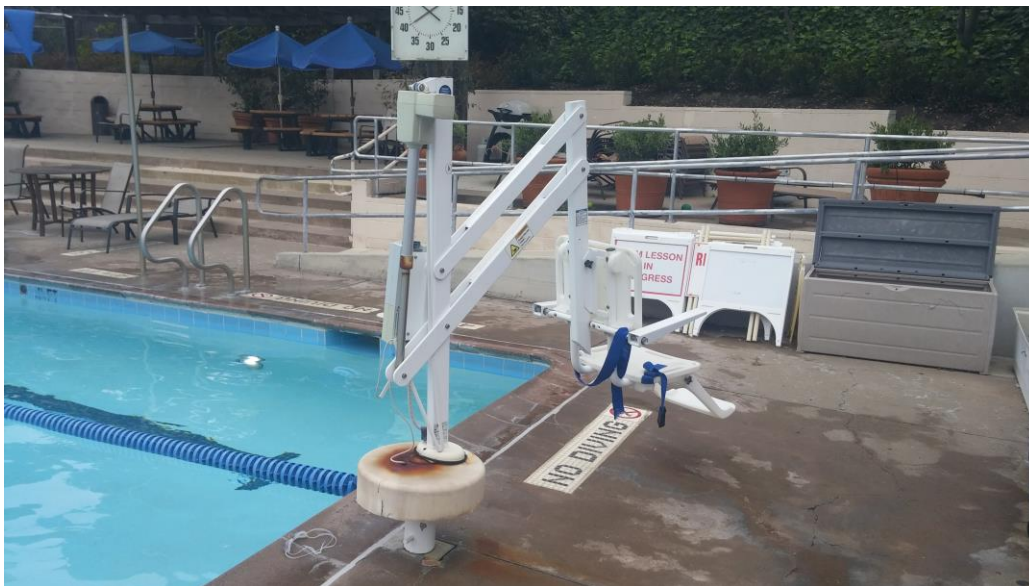
PP-22 Main Pool ADA pool lift not working

2. Repair or replace the main pool lift.

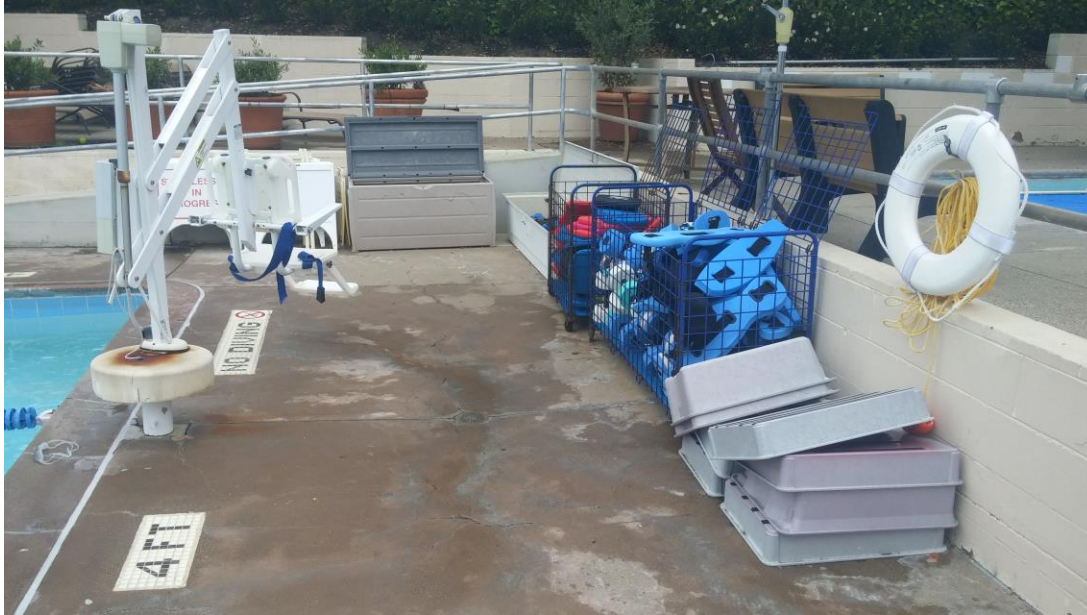
- G. The Main Pool deck is cluttered with pool equipment (i.e. kick boards, exercise pedestals, etc.), as is the deck area adjacent the Wading Pool. Storage appears to be in short supply. PP-23

PP-23 Deck cluttered with pool equipment

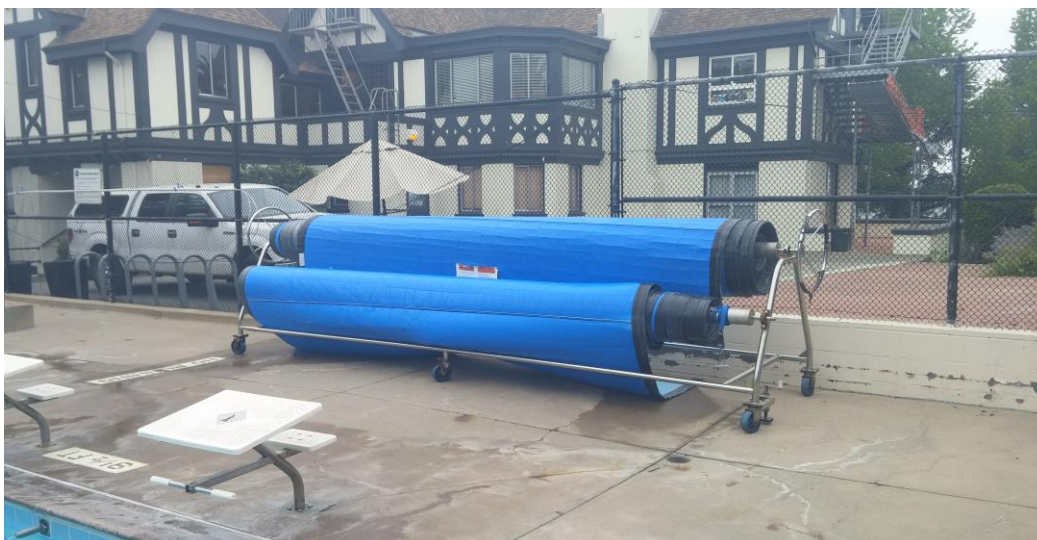
- H. The pool covers are damaged by exposure to the direct ultra violet light from the sun. After being rolled up the same section is exposed every day. The addition of simple, inexpensive covers will extend the life of the covers measurably. The same is true for the lane line reels not pictured. PP-24

PP-24 Exposed pool covers

Purchase covers for pool cover reels.

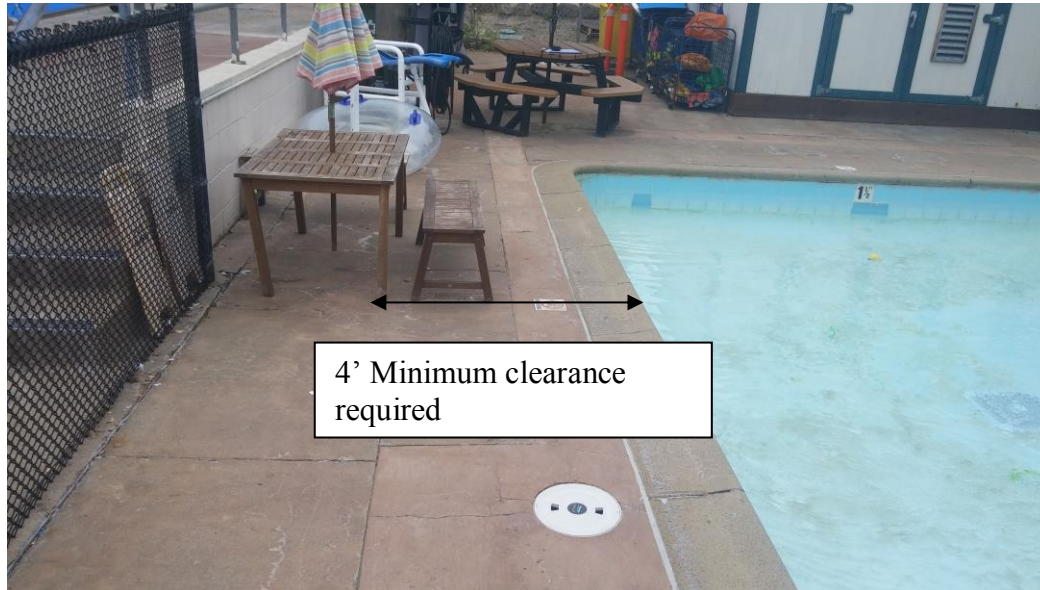
- I. The surrounding Wading Pool deck area did not provide the minimum 4' clearance as called for by CHSC. PP-25

PP-25 Deck clearance issue

Move deck furniture to comply with clearance.

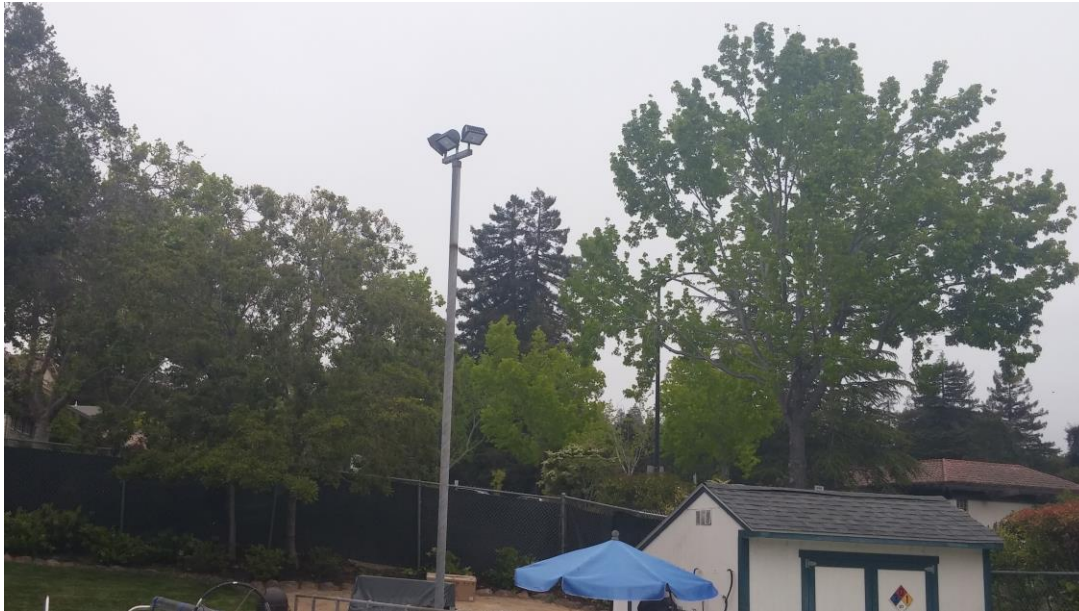
- J. The deck pool lighting is minimal at best according to staff. Some lighting has been added in recent years but does still not cover all the deck areas. It is unknown if the minimum lumens required is met throughout the facility. PP-26, 27

PP-26 Deck lighting

Have the deck lighting tested by a trained electrical/lighting contractor. Add additional lights as necessary to comply with code.

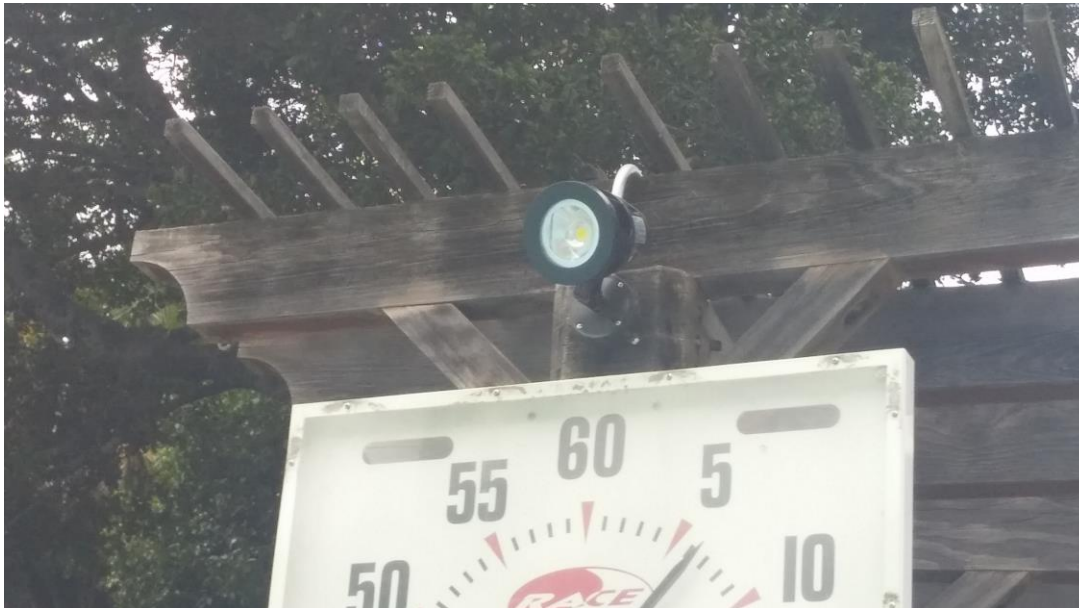
PP-27 Deck lighting (patio)

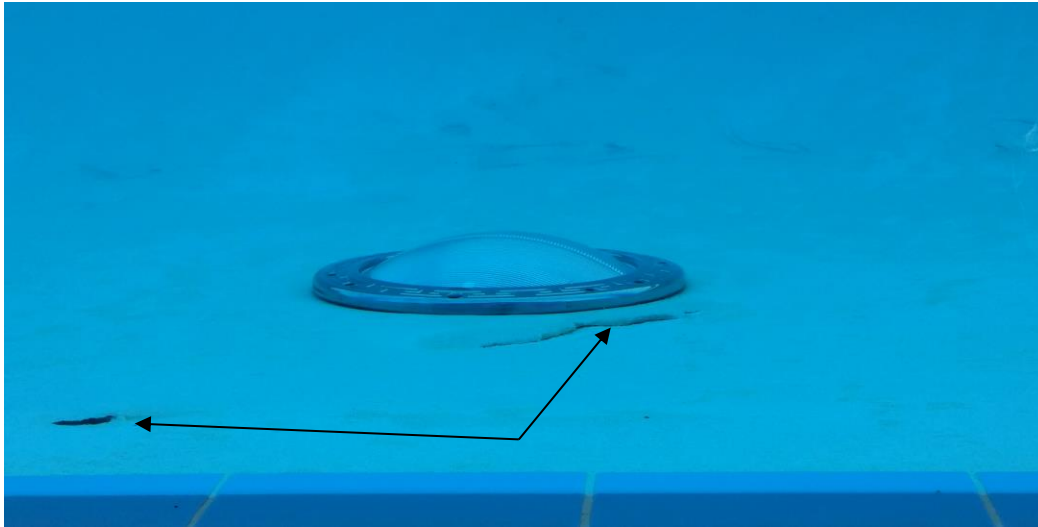
- A. The Main Pool plaster is in fair condition except there are several areas of stains and a few plaster cracks. One particular crack that is on the office side pool wall presents a safety hazard. Several waterline tiles have been replaced over the years with a different color than the original tile, which detracts from the aesthetics of the pool. PP-28

PP-28 Plaster cracks and staining on Main Pool

Complete plaster patching to eliminate the rugged edges of the exposed plaster.

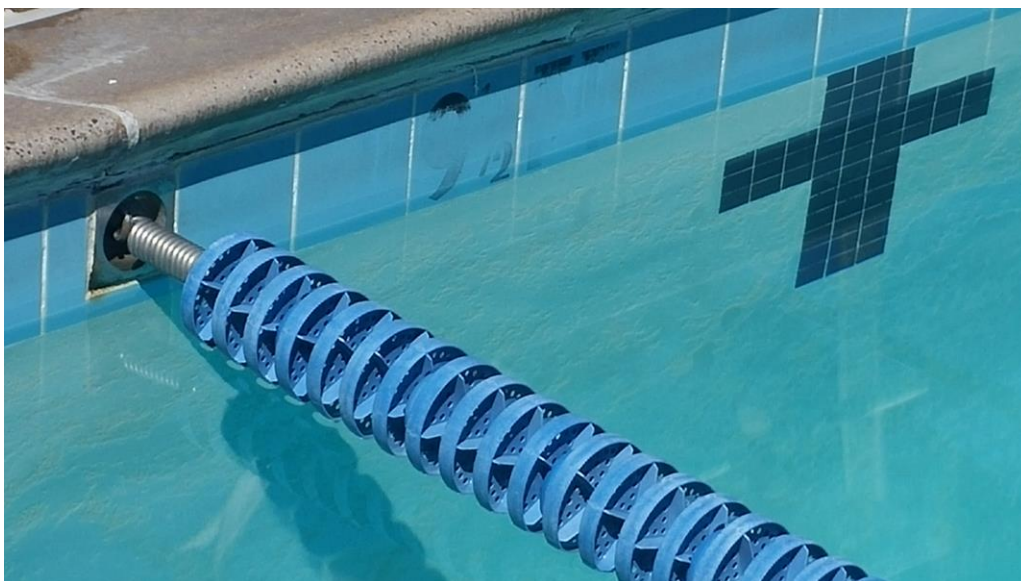
- B. Most all of the waterline depth marker tiles are well faded with several unreadable. This falls short of the CHSC. There are several tiles that are cracked. PP- 29

PP-29 Faded waterline depth markers on Main Pool

Replace any broken or cracked tile that presents a safety hazard.

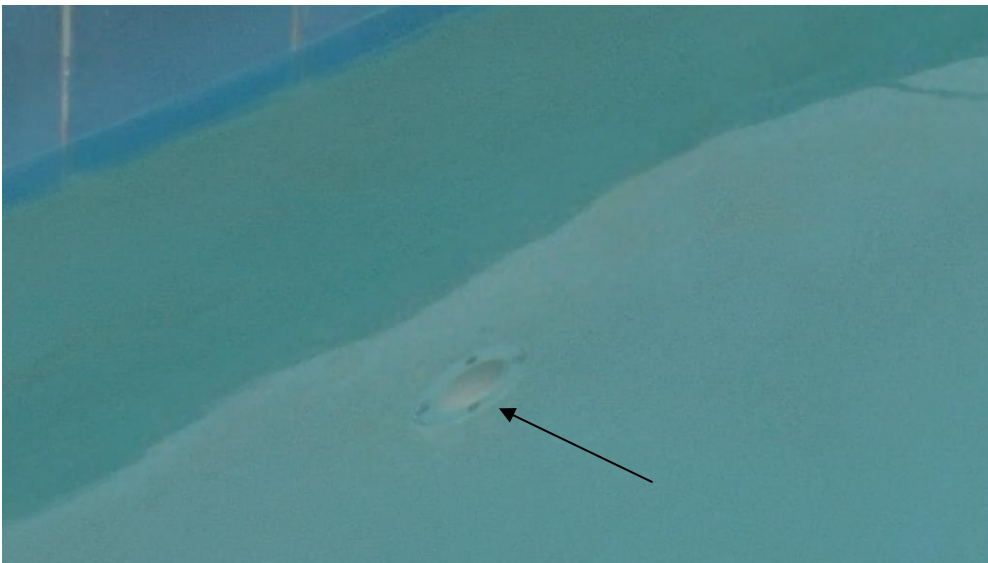
- E. There are several missing recessed eyeball inlet fittings in the Main Pool. These are required by CHSC to direct the flow downward from the surface. PP-30

PP-30 Missing return inlets on Main Pool

Purchase and install all missing or damaged pool wall return inlets.

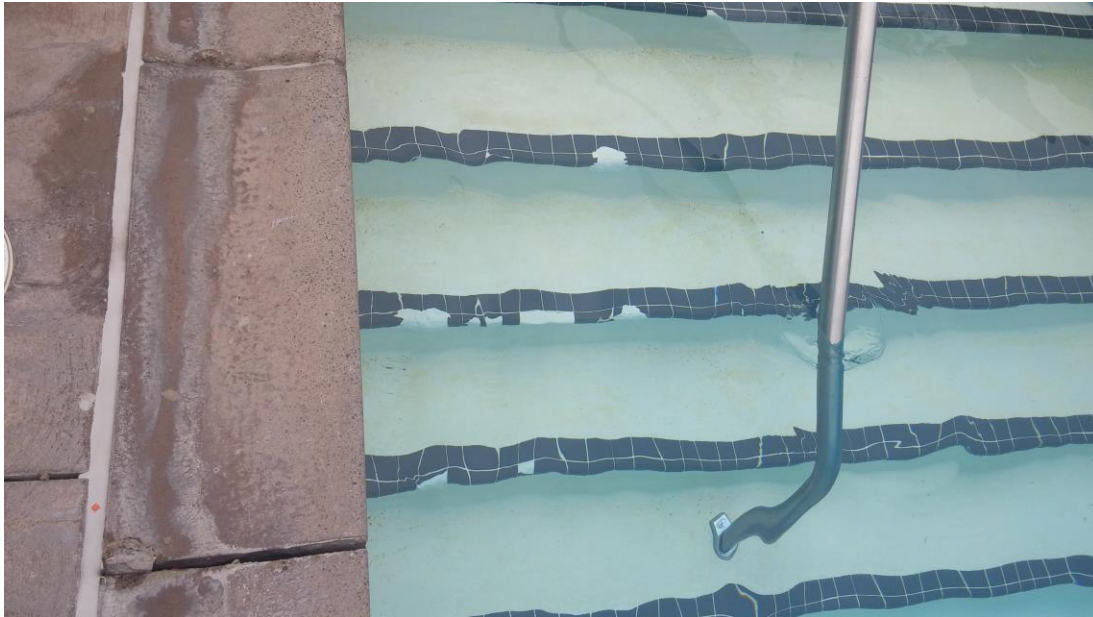
- F. The pool steps in the Main Pool have missing tiles and cracks in the plaster that have been filled with underwater epoxy. The steps are usable but are certainly un-slightly. PP-31

PP-31 Steps and tiles missing on Main Pool

Recommendation: None at this time
