City of Piedmont
CITY COUNCIL AGENDA REPORT

SUBJECT: Receipt of a Presentation from Richard Young of Aquatic Commercial Consulting Regarding a Current Condition Assessment of the Piedmont Community Pool

City of Piedmont Community Swimming Pool Facility Pool Evaluation

September 2018

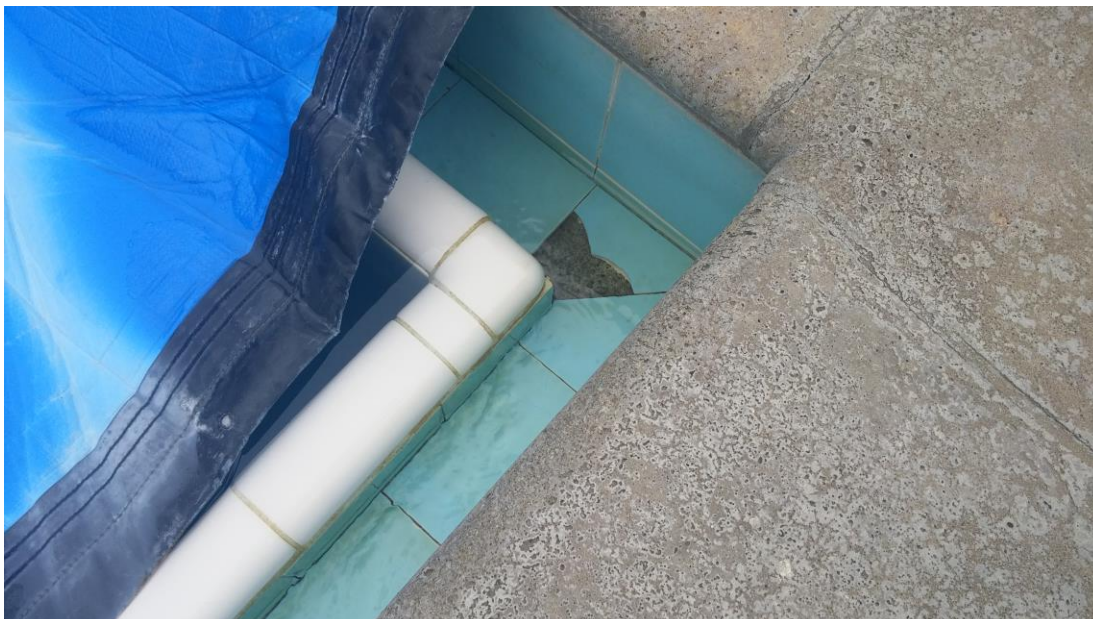
- A. The Medium Pool has several issues with cracked tile and gutter drains. The drains have been replaced but were not set properly in the gutter. PP- 32, 33

PP-32 Tile issues on Medium Pool

Repair any tiles that may be a safety hazard. This can be completed with underwater epoxy to cover any sharp edges.

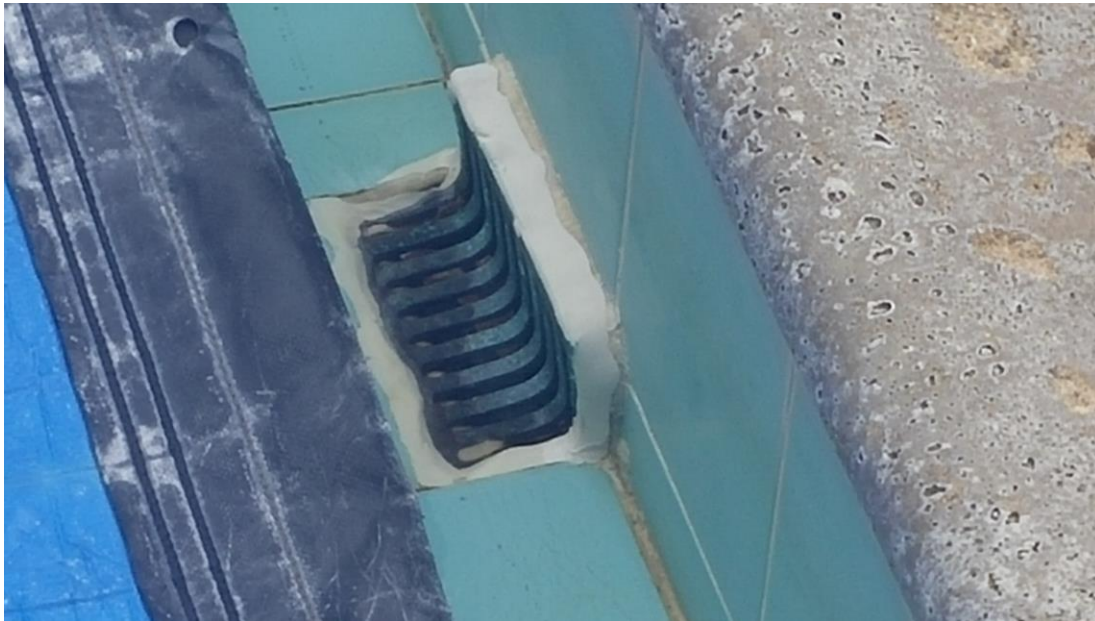
MEDIUM POOL: Staff reports the medium pool loses considerable water. This pool is fitted with an automatic fill device in the surge pit, so the loss only becomes evident upon turn off of the automatic fill. No firm estimate on water loss is available, however, the deck area adjacent the pool is considerably out of level, with several concrete edges having dangerous trip hazards. PP-33, 34

PP-33 Gutter drains not properly set on Medium Pool

Make repairs only if this portion of the plumbing is proven, through the destructive testing, to be the source of the pool leak. This will require plumbing, concrete and tile work.

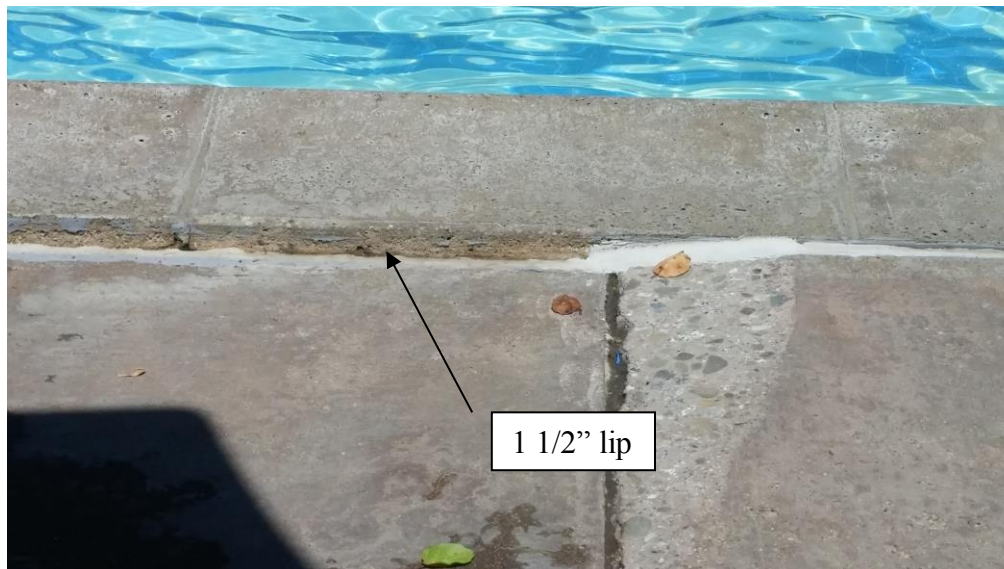
Water will saturate the soil adjacent and beneath the pool. Depending upon the soils type, much of the water may be absorbed and dissipate into the surrounding soil. At the point of the leak, some soil erosion may be taking place as evidenced by the out of level deck sections. However, it appears sections of the deck, especially around the Medium Pool have become out of level, indicating soil erosion and/or expansive soil.

- D. Staff reports Medium Pool continually loses water. The automatic fill system compensates for the water loss. But the line is not equipped with a water meter to determine the amount of replacement water used on a daily basis. It is evident there are soil issues occurring as the deck has dropped and has left the pool edge/deck interface uneven which presents a trip hazard. This circulation system could not be pressure tested at it makes use of the surge tank with gravity flow lines. Destructive testing would be required to determine if the leak is in the collection or return lines. The adjacent concrete sections near the deep side of the training pool have been dislodged. PP-34

PP-34 Uneven deck sections around Medium Pool

Complete the destructive testing required to pressure test and conduct leak detection. This may require replacement of the deck area on the deep side of the pool. Make repairs. NOTE: The location of this leak is unknown.

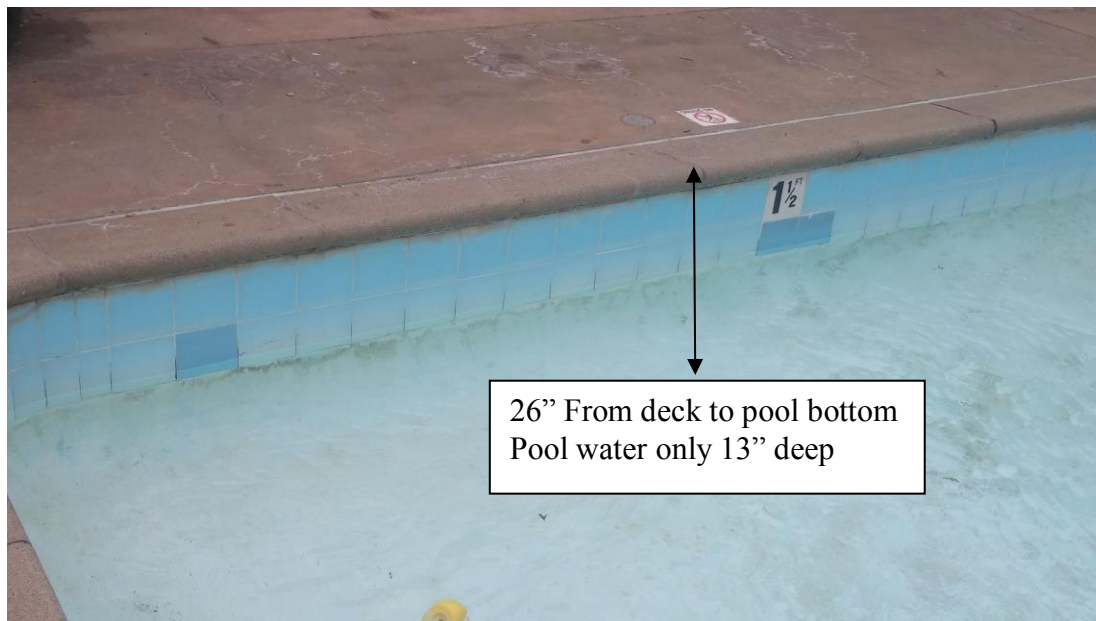
- A. The Wading Pool is 26" from the deck to the pool bottom and the water is only 13" deep. The depth markers indicate 1.5' (18") so the actual drop is 26" if someone were to step off the pool edge. With the water level being only 13" as opposed to 18" as labeled on the tile depth markers, the result could cause serious injury. PP-35, 36

PP-35 Step off from pool deck into 13" of water – Wading Pool

1. Add deck signage that calls for entry to the pool at the steps only. (See also deck issues for handrails).
2. Raise the water level as far as possible to bring the depth as close to the 1.5' and still have the skimmers operate.

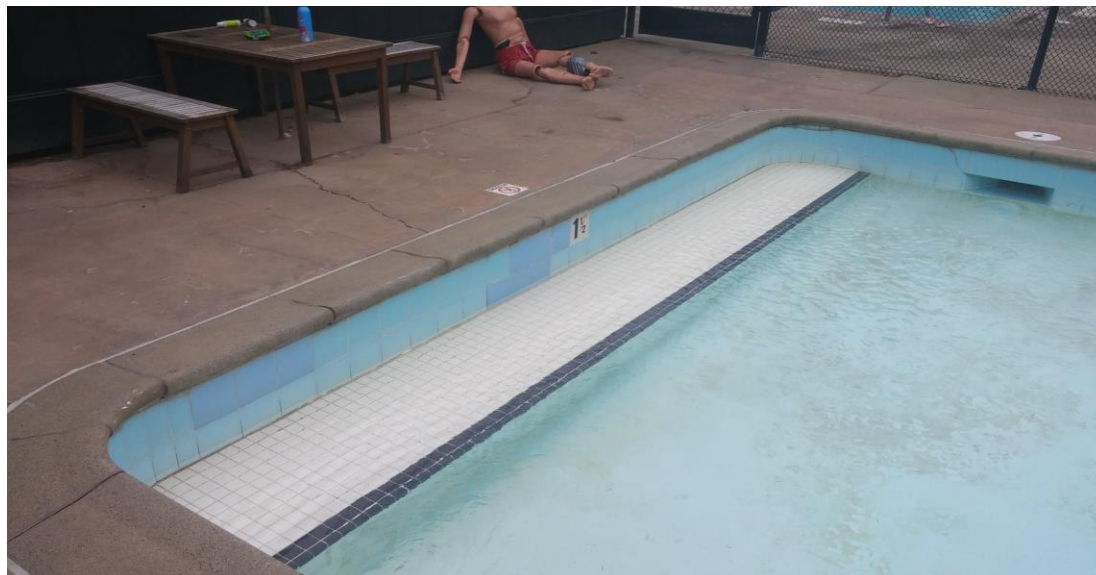
PP-36 Wading Pool shallow water

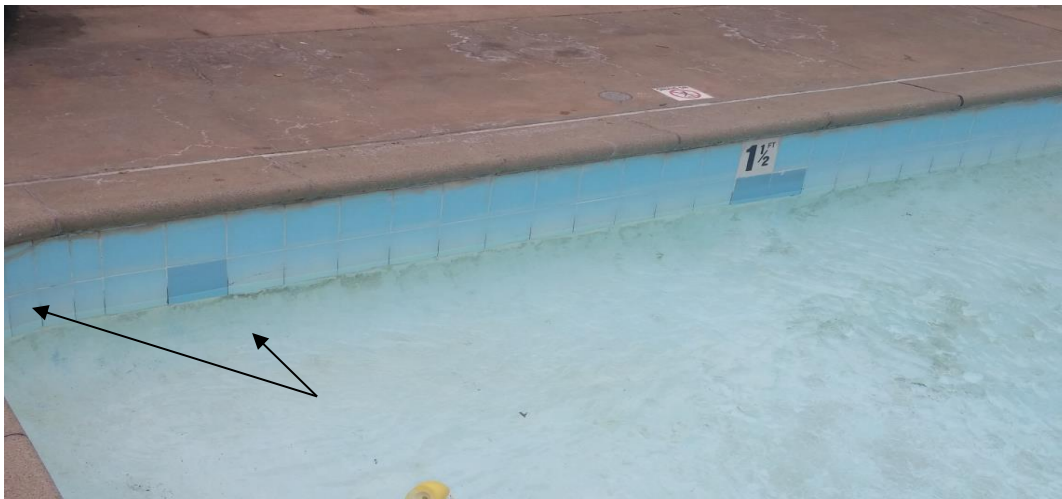
B. The Wading Pool has several cracked waterline tiles. PP-37

PP-37 Cracked waterline tiles on Wading Pool

Replace/repair any tiles that might present a safety hazard.

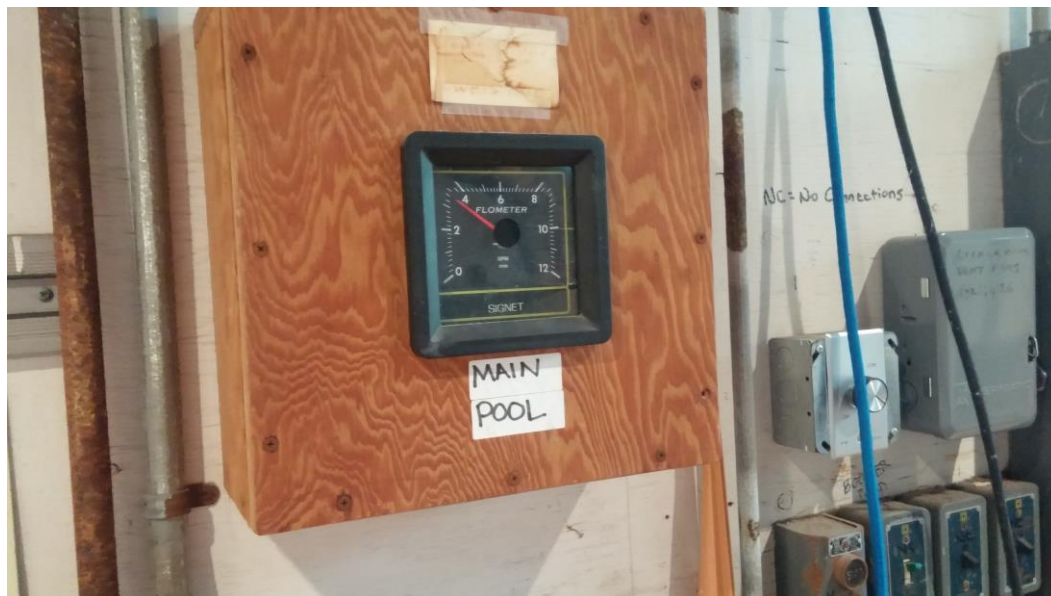
PP-38 Normal flow meter reading (should be 430 GPM)

1. Install a new PACO 4095-7 (keep 10 HP motor)

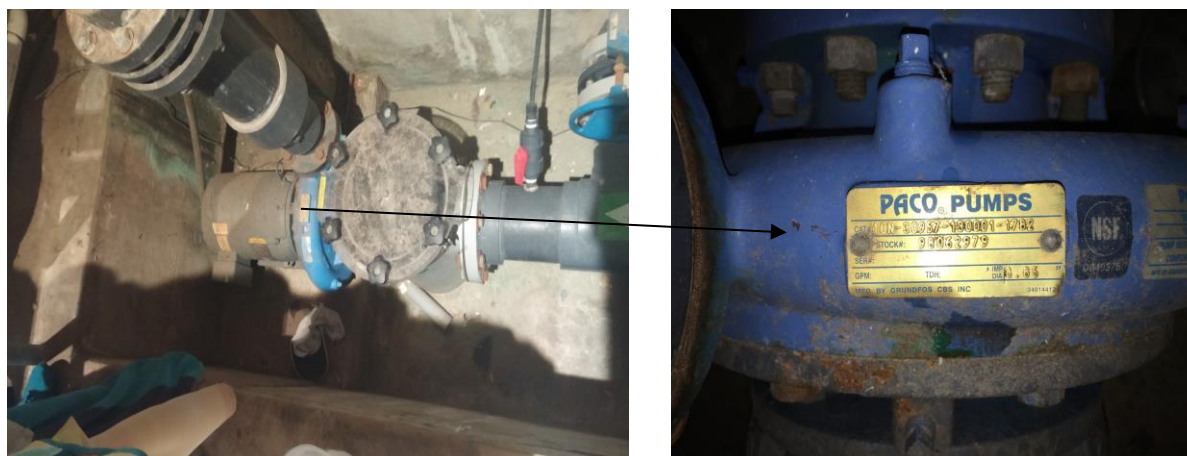
PP-39 Main Pool pump

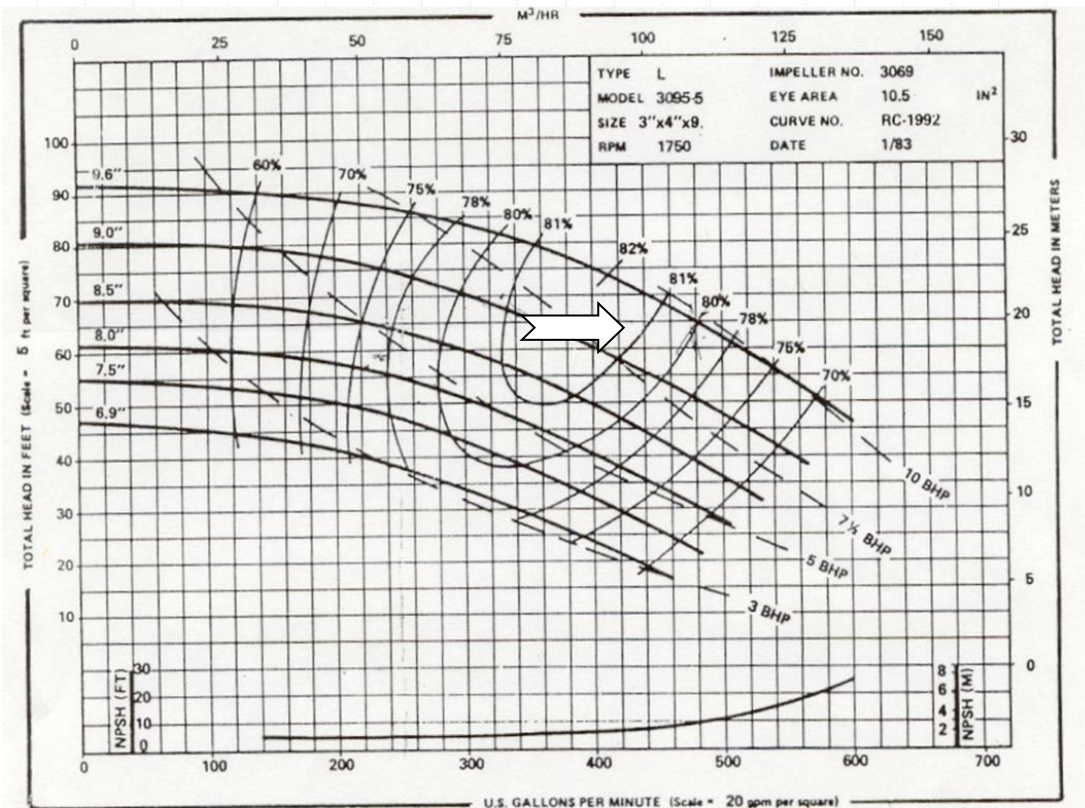
Pump Curve of existing unit. (Target for flow and pressure off 10 HP curve)

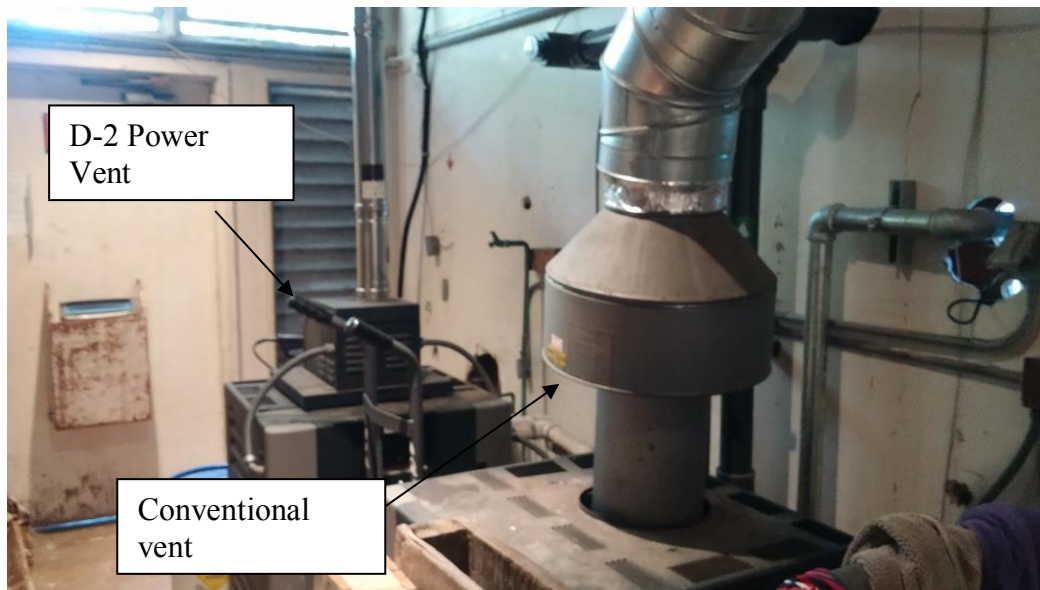
PP-40 Pool heater with standard flue

Install a new Hayward D-2 power vent and install Type III, stainless steel flue to the exterior of the mechanical area

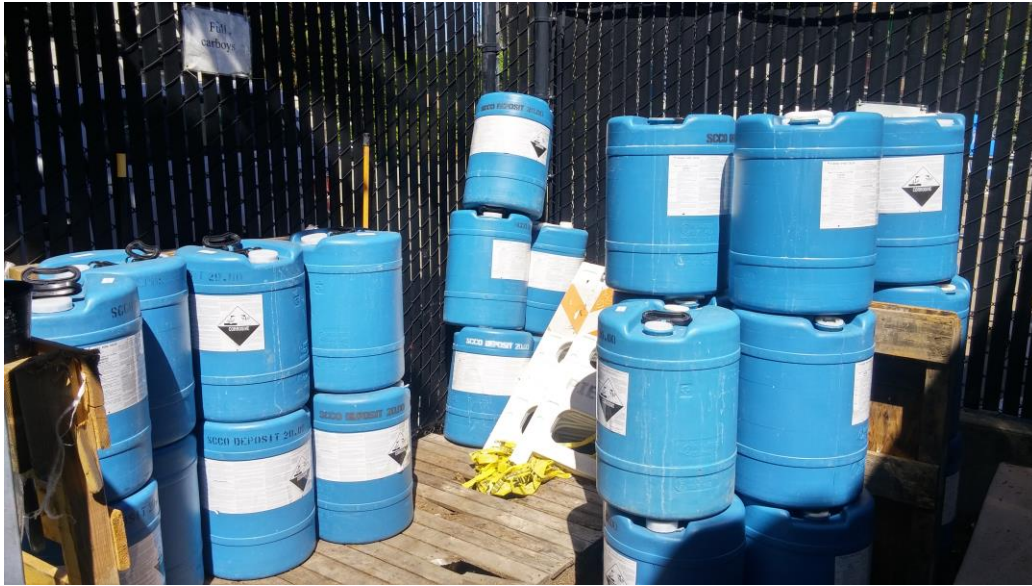
- B. The chemical feed pumps are UL and NSF listed and draw chemicals from the actual shipping containers. Only some of the containers are properly double contained on containment pallets. The majority of the chlorine and acid containers stored in a fenced area adjacent to the pool office and mechanical room are without double containment per UFC, Article 80, OSHA, MAHC codes and standards. PP-43, 44

This area naturally drains down the hill onto the walk way and presents a significant safety risk.

PP-43 Non-compliant chlorine storage

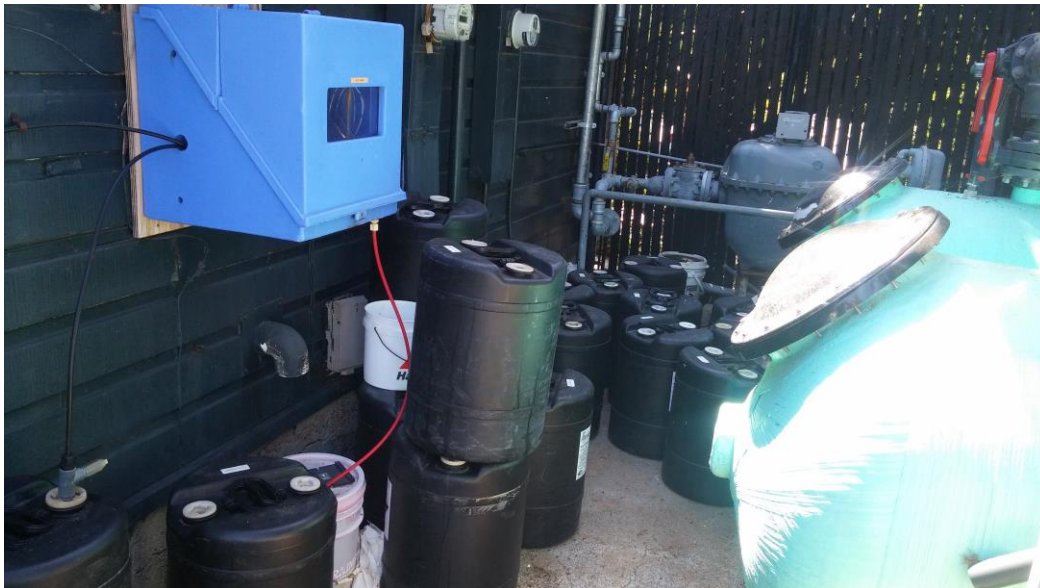
PP-44 Non-compliant acid storage

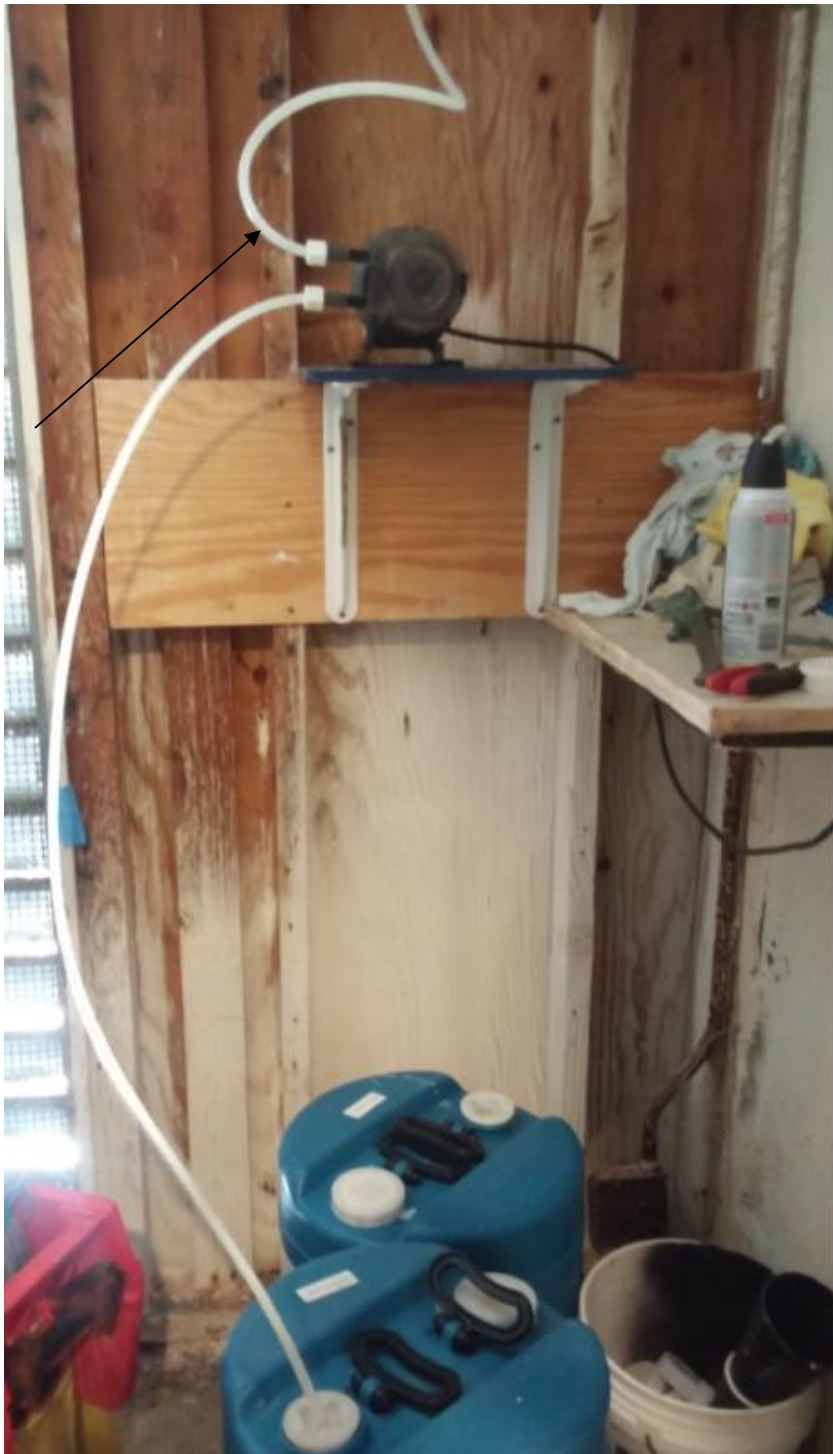
C. The chemical feed lines for both chlorine and acid are not double contained. PP-45

PP-45 Chemical lines not double contained

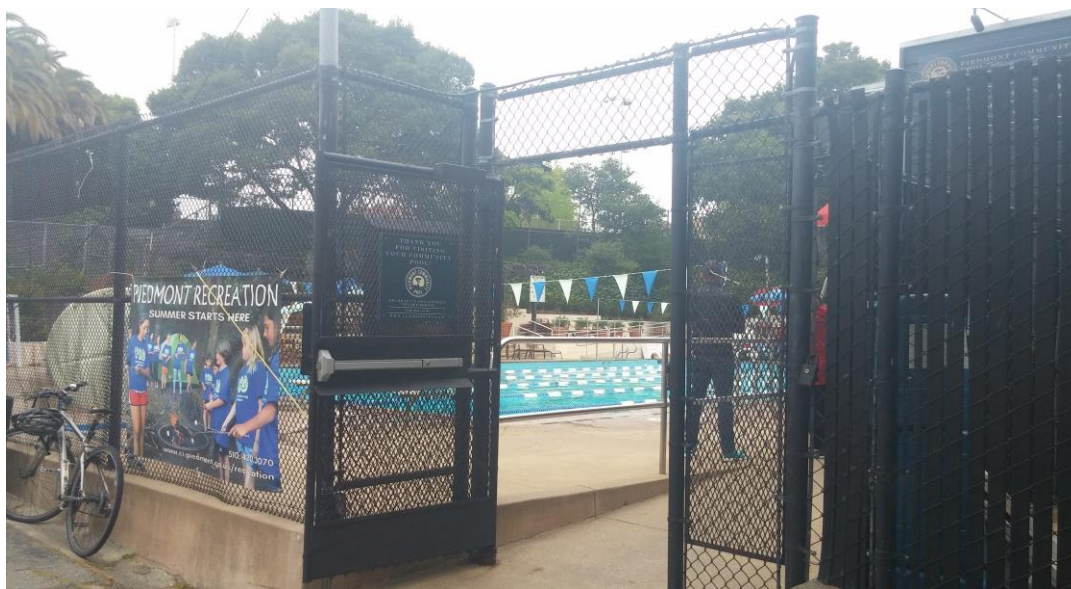
PP-46 Pool Entry - Does not close and is not ADA compliant.

1. Make necessary adjustment to the gate hardware to insure the gate is self-closing and self-latching.

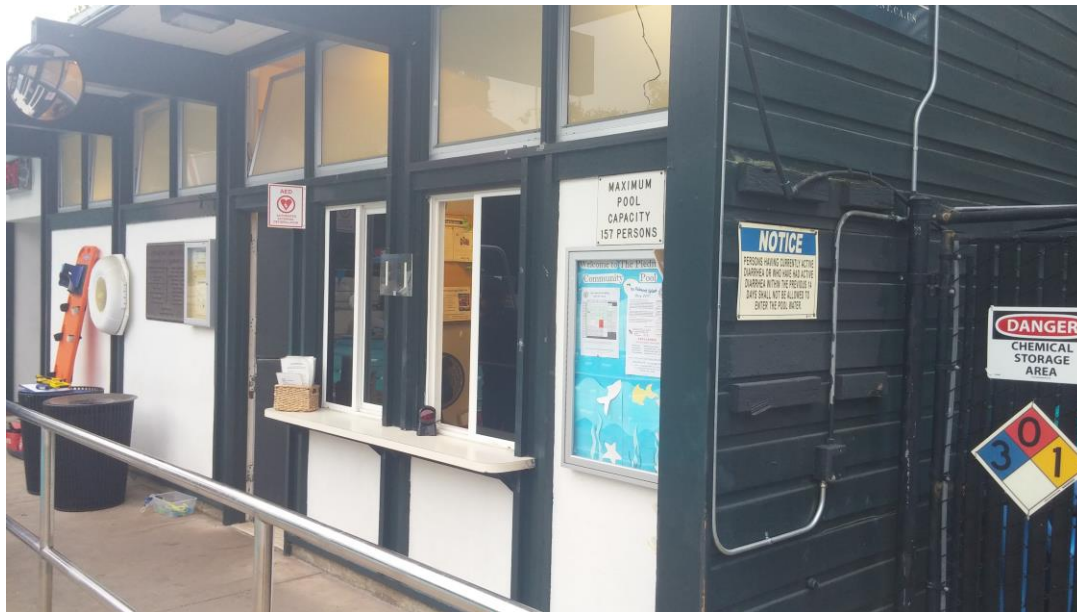
PP-47 Entry area, limited office personnel visibility

No major changes in the office configuration are recommended at this time. However, office personnel seated or working on the computer looking away from the entry need to know someone has entered.

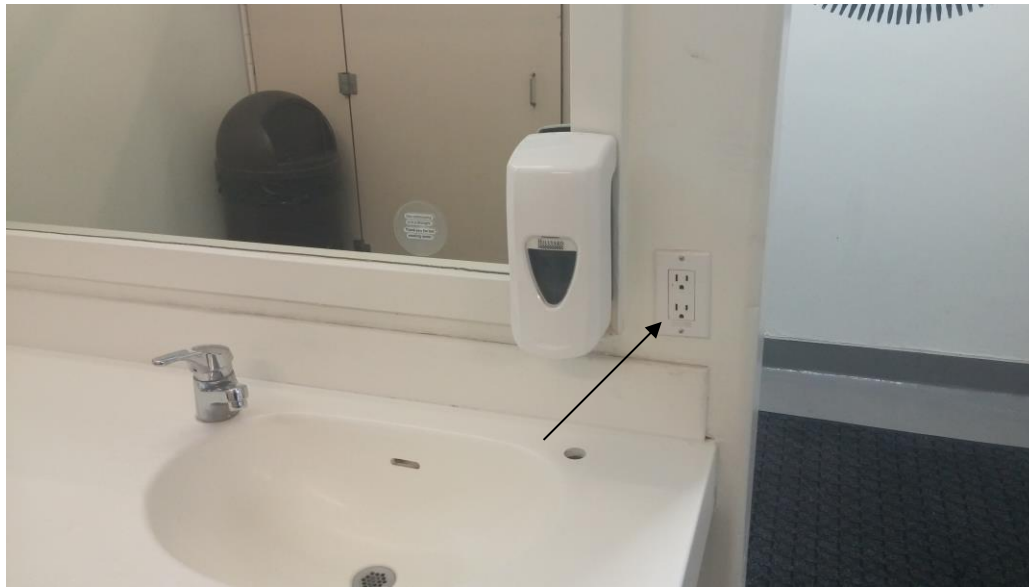
PP-48 Men's Dressing Room non-compliant electrical

Recommendation:
Install and test a compliant receptacle.
